# The Destruction of Part of the Ancient City of Cihuatán

## *Summary through April, 2010*

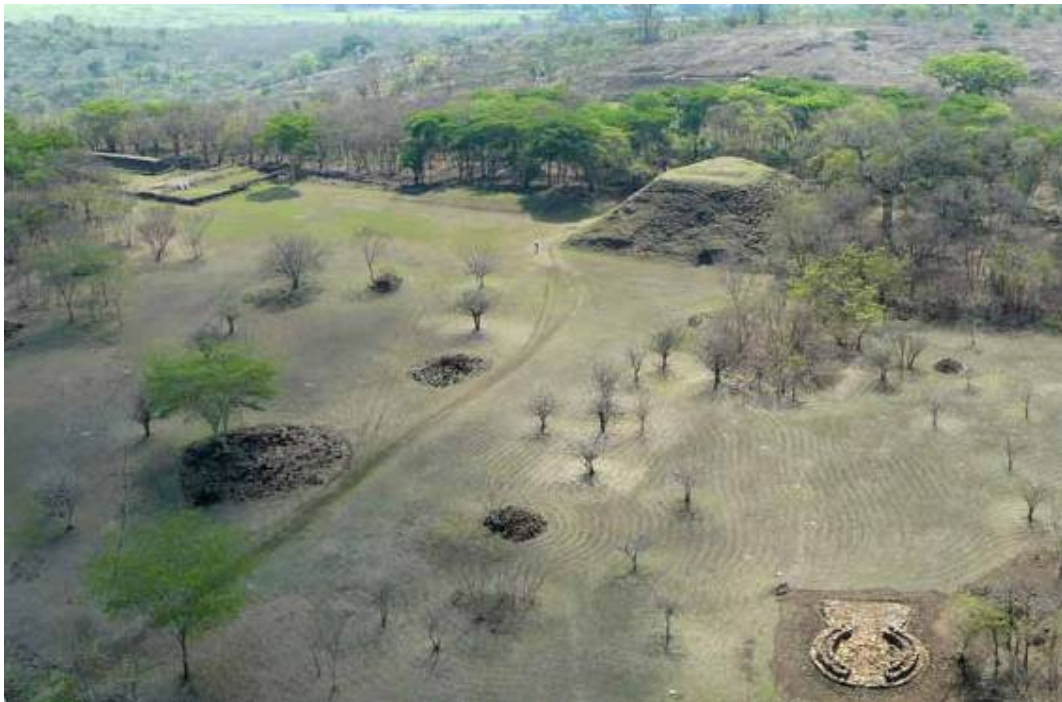
Air photo of Cihuatán's ceremonial precinct, with the North Ball Court, the main pyramid (Structure P-7), and the wind temple (Structure P-28). The Acropolis, where the royal palace of the ancient city is located, can be seen in the background.

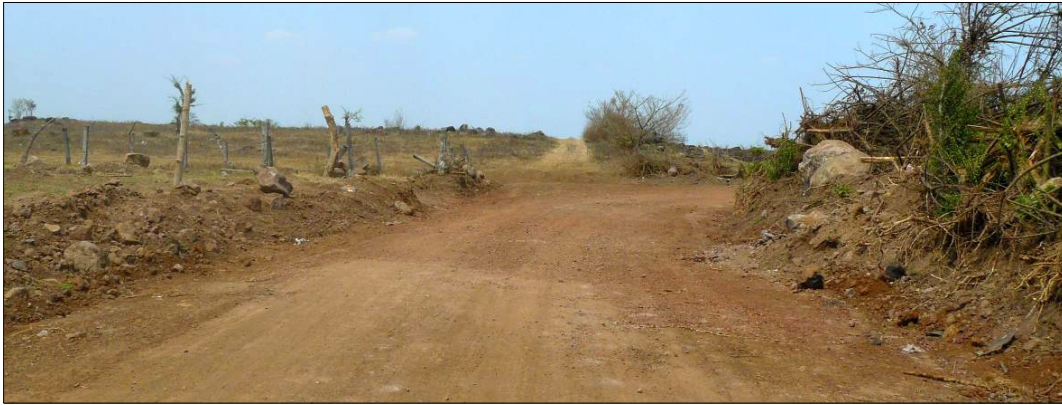
The new access road. This road and its branches extend for over 1,300 meters (0.8 miles), with a width of 10 meters (33 feet). The bulldozers graded down to the culturally sterile reddish subsoil, destroying archaeological deposits including structures, along its route.

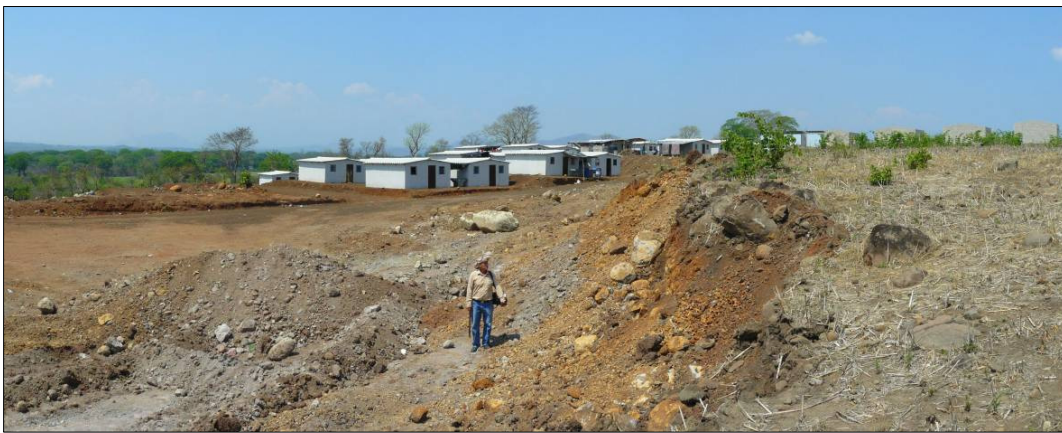
The housing project. In this area the bulldozers cut to depths greater than 3 meters (10 feet).

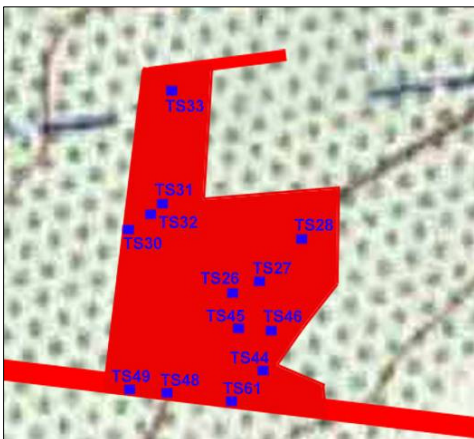
The bulldozers and other construction work destroyed several prehispanic structures which were recorded during the archaeological reconnaissance conducted by FUNDAR and reported in 2003.

These structures are here marked in blue within the area affected by the housing project (shown in red). The labels correspond to their descriptions contained in the 2003 report. In addition to these superficial structures, there can be no doubt that several others which were not visible during the reconnaissance were also damaged or destroyed, along with other kinds of archaeological features.
